POST-MEDIEVAL ARCHAEOLOGY AT WYFOLD GRANGE, OXFORDSHIRE

Abstract

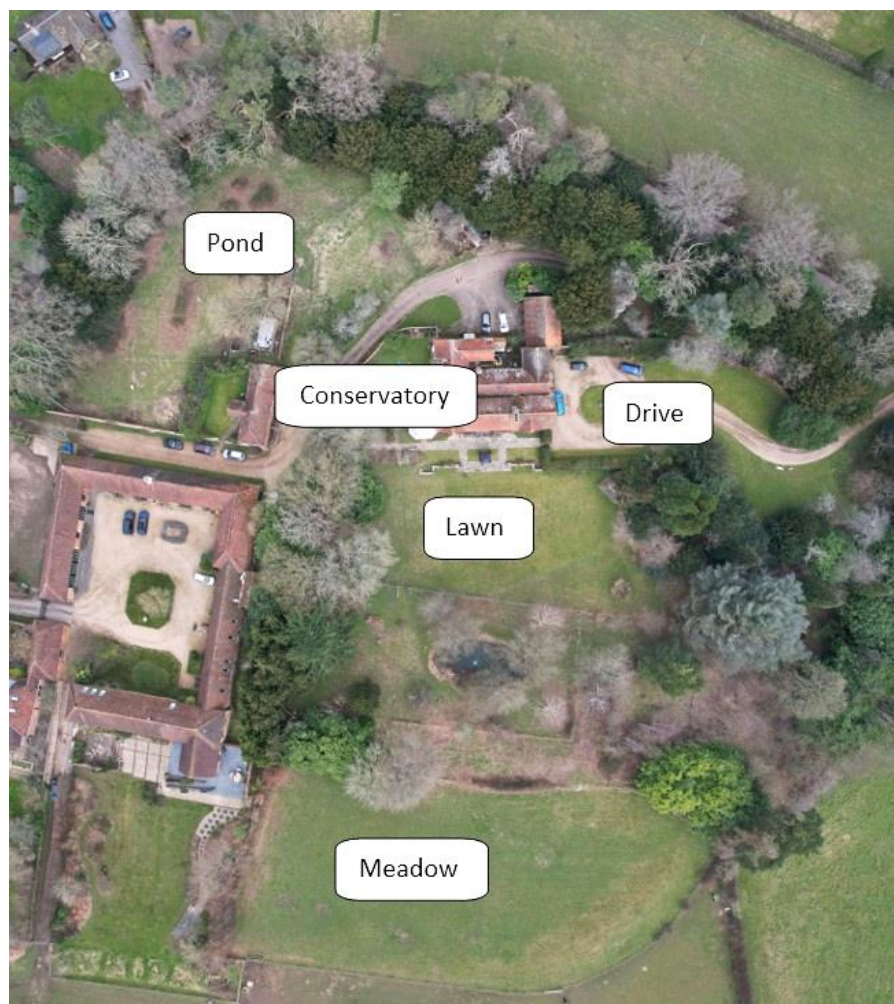
Magnetometry and resistivity surveys were undertaken over all sufficiently clear areas within the earthwork enclosure, Figure 2. The aim was to identify any underground features which might relate to former occupation or other use of the grounds of Wyfold Grange with the potential for further investigation by excavation.

Figure 2. Location of the five geophysical survey areas

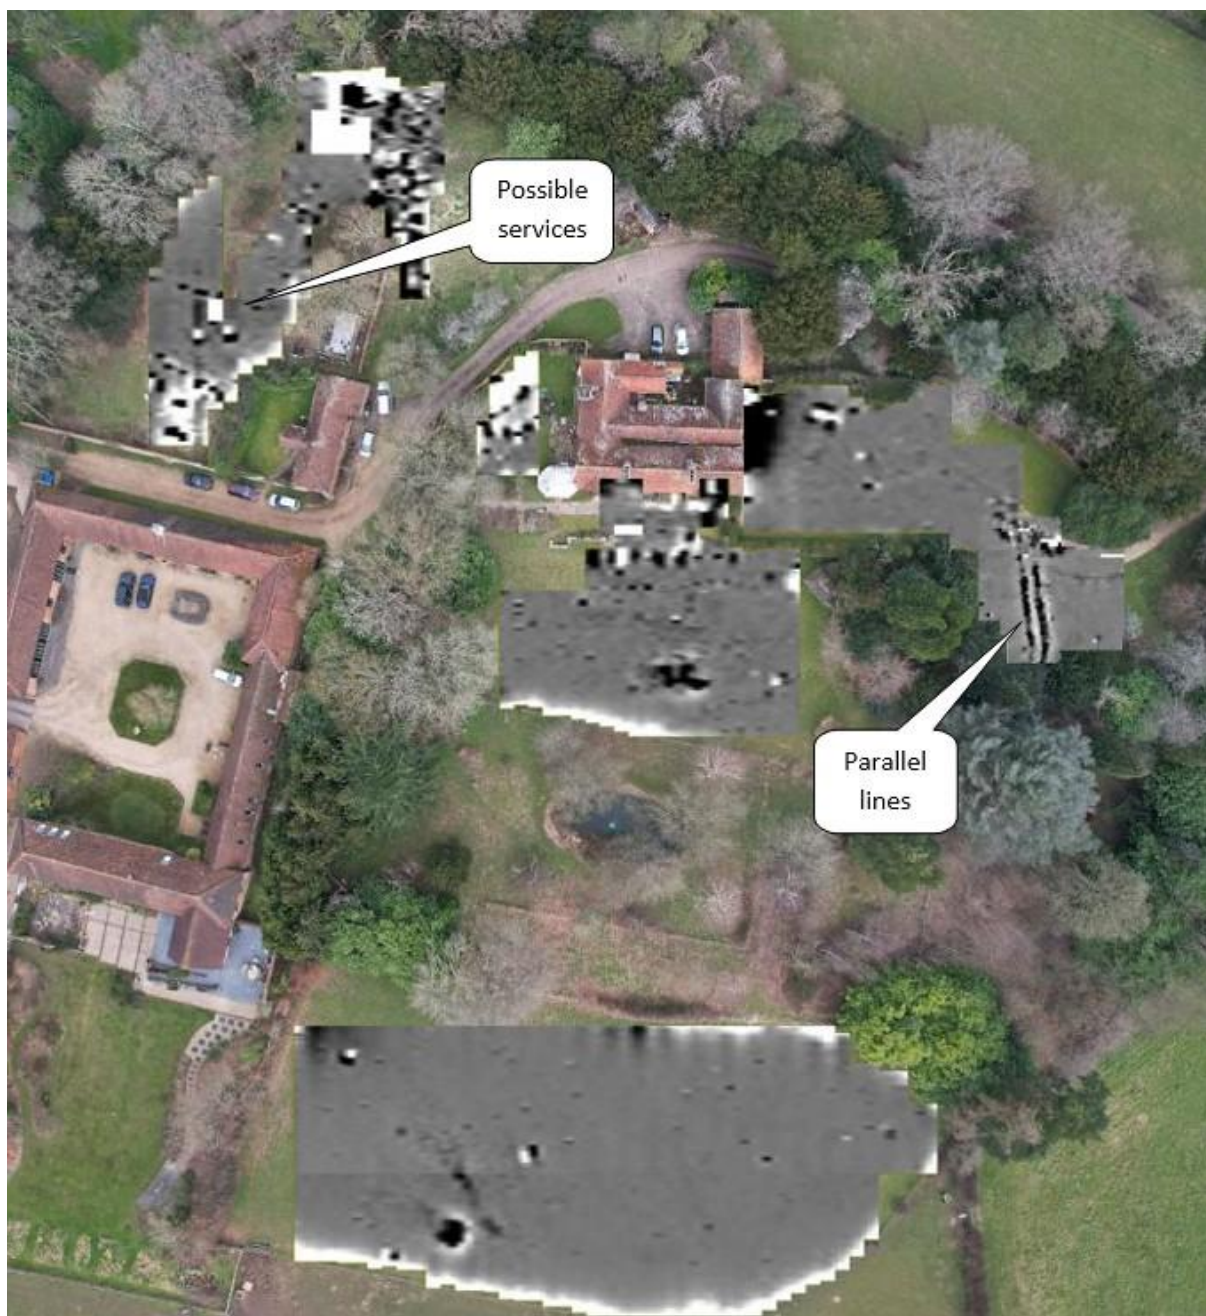
The survey results have been georeferenced to a drone photograph of the Grange property. These are shown in Figure 3 and Figure 4.

Figure 3. The magnetometer survey georeferenced to aerial photograph

The magnetometer survey showed two parallel lines, possibly a double track, heading south off the east driveway. As this was not clear on the resistivity survey it was not investigated further, but it is thought that this is possibly caused by sub surface vehicle ruts.

Both magnetometry and resistivity show the path of what could be services to the NW of the property.

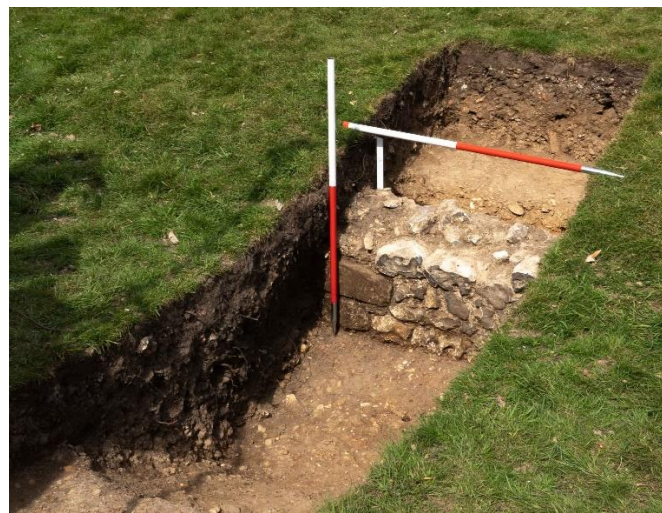
Following removal of turf and topsoil, the base of a stone wall (Context 304) was discovered, about 40 cm wide and running roughly E - W across the trench, Figure 7.

Figure 7. Trench 3 showing the base of a flint wall

The mortared surface, emerging at a depth of about 45cm, comprised worked flints, with faces showing to the south. A couple of courses down two securely mortared, dressed blocks of limestone, 20-25cms long were exposed. To the north of the wall, there was a substantial quantity of infill (Context 303), which had been used to raise and level the lawn, comprising sandy brown soil and rubble - including roof tile fragments, mortar and some faced flints. This material also extended slightly over the line of the wall into the context below. To the south of the wall a shallow ditch was evident, filled with soil, CBM and numerous 19th and 20th century household items (Context 305). Further south, beyond the ditch the ground was flat and undisturbed.

It seems unlikely that the wall could be the remains of a Ha-Ha, given the maximum elevation of no more than 1m from the bottom of the ditch to the, apparently raised, upper lawn. The Ha-Ha at Grey's Court for example, is at least 1.4 metres high. Interpretation of this wall is discussed in Section 5, below.

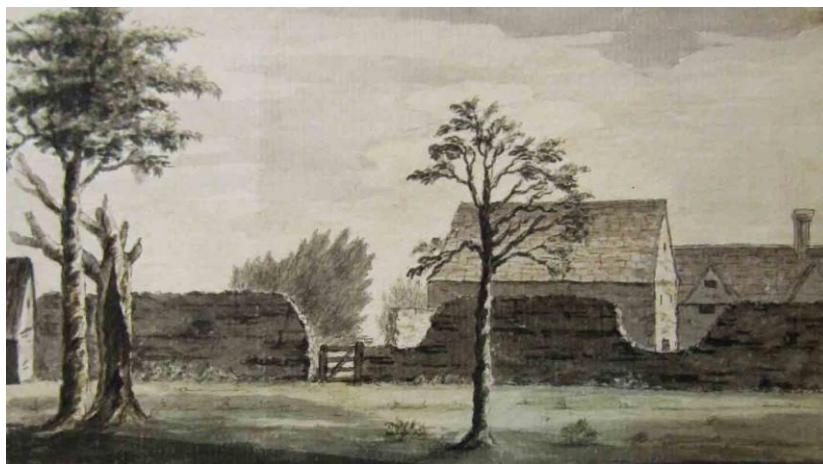
Figure 8. Water colour entitled “South View of Wyfold Priory Oxfordshire April the 13. 1762”. Artist unknown. Bodleian Library a.

The earliest known drawing was from 1762, Figure 8, which shows a walled area including a house and barn, and the end of a further building outside the wall to the left of the picture (Bodleian Library a). The condition of the stone wall suggests considerable age at the time of drawing and so it could potentially derive from medieval monastic times.

Given that the watercolour is identified as a “South View” it seems likely that the remains of the wall found in Trench 3 are the footings of the wall depicted in Figure 8. Close inspection of Figure 9, a 20th century postcard of Wyfold Grange, confirms the remains of a stone wall running across the lawn in an east-west direction which is very likely a continuation of the wall found in Trench 3. The line of this wall can also be seen in the 1898 Ordnance Survey map (Figure 1) just north and west of the word “Wyfold”.

In Section 4 a crude estimate was made of the potential size of building that could be roofed by the ceramic tiles found in the lawn excavations. It was suggested that this could be a building of around 8m x 8m. Perhaps this represents the remains of the barn shown in Figure 8 which is located at the west end of the present lawn.

The building to the extreme left Figure 8 appears to be in the position of the northern range of the present stables building. The Tithe Apportionment map for Checkendon (Figure 10) shows the stables buildings and courtyard configured similarly to their present arrangement (now in use as a domestic residence) but with no eastern range. The Tithe map of Rotherfield Peppard (Figure 11) also includes representations of Wyfold Grange as the boundary between the parishes passes right through the house (see also Figure 1). The location of the house on both Tithe maps is similar to that of the present house in relation to the other buildings and the pond.

In summary, the physical evidence from Trench 3 confirms the wall shown on the 1762 drawing, which is still evident above ground on the 1898 Ordnance Survey map and the 1921 photographic postcard. The house and stables buildings on the drawing appear in a correct relationship to the wall as indicated on the Tithe Apportionment maps of 1841. The barn on the drawing, now missing, may have left traces in the large quantity of roof tile fragments found in the present lawn, where it used to be situated. This convergence of documentary and archaeological evidence serves to confirm the veracity of the 1762 drawing.

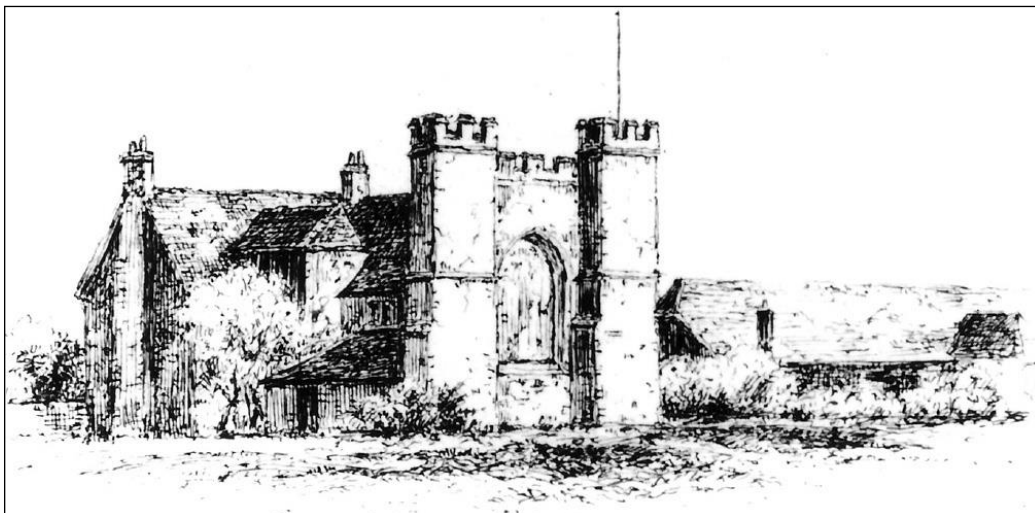
Figure 12. Pen and Ink drawing of Wyfold Grange, 1868, possibly from the northeast. Bodleian Library (b).

A drawing of 1868, just a few years before its demolition, (Figure 12) shows Wyfold Court as a very grand house with twin castellated towers with a large gothic window between, and a large barn to the right (Bodleian Library, b). The Bodleian cataloguing says “possibly fanciful or mislabelled, or showing a mock-medieval addition”. To what extent this drawing is a realistic representation of the house in 1868 is assessed below.

The perspective of the 1868 drawing suggests that it must be a view from the northeast and the barn must be the predecessor of the present stables building, which, as has been discussed above, is confirmed on the Checkendon Tithe Apportionment map (Figure 10). It is also possible to reconcile the Figure 8 view (from the south), the Figure 12 view (from the northeast) and the T-shaped building on the Rotherfield Peppard Tithe Apportionment map (Figure 11). It should also be noted that our excavation of a short section of wall (Trench 3, see Section 4 above) revealed the presence of recycled dressed stone on the site suggesting that there had been at least one stone building at some time.

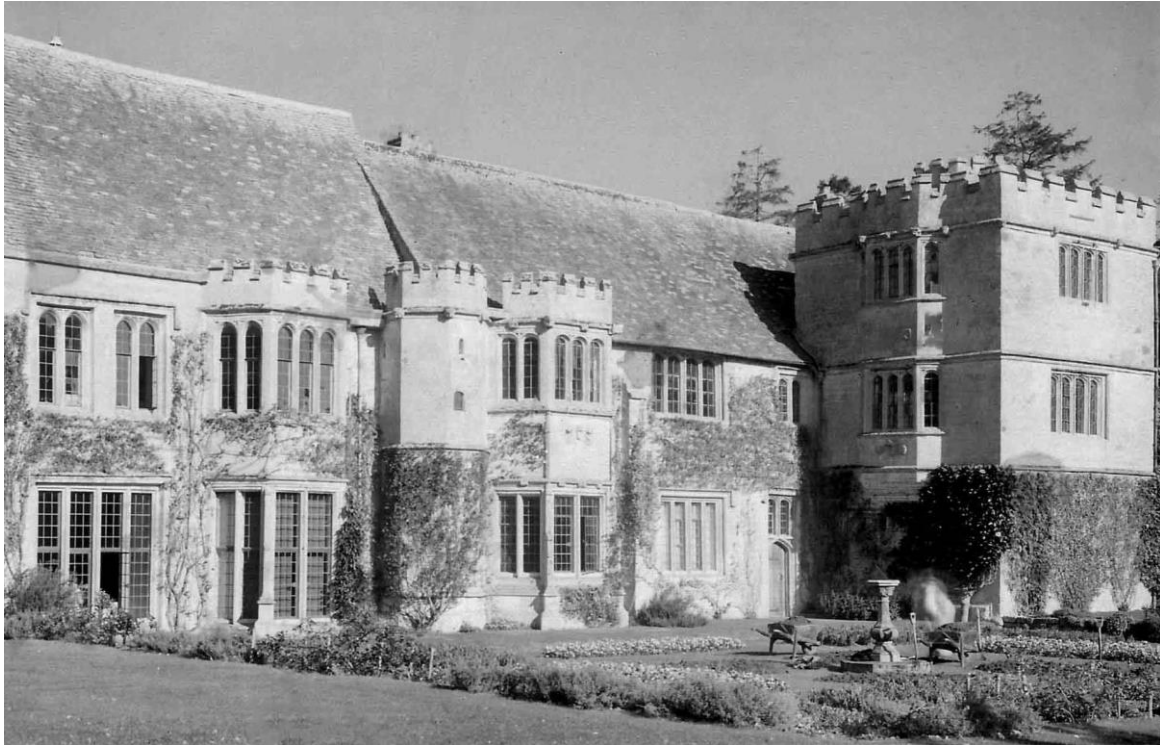
Figure 13. The south range of Thame Park. Courtesy of Thame Museum

In their detailing, the castellated towers are somewhat reminiscent of remaining parts of Thame Abbey, now called Thame Park (Figure 13). Oxford Archaeology undertook a Heritage Assessment and Survey of Thame Park (SMJ, 2002, p60). They concluded that parts of the present building “*incorporate substantial surviving elements from the medieval monastic buildings of the Cistercian Abbey*”. The western part of the south range (the left-hand section on Figure 13) “*belongs to the earliest phase of construction*”.

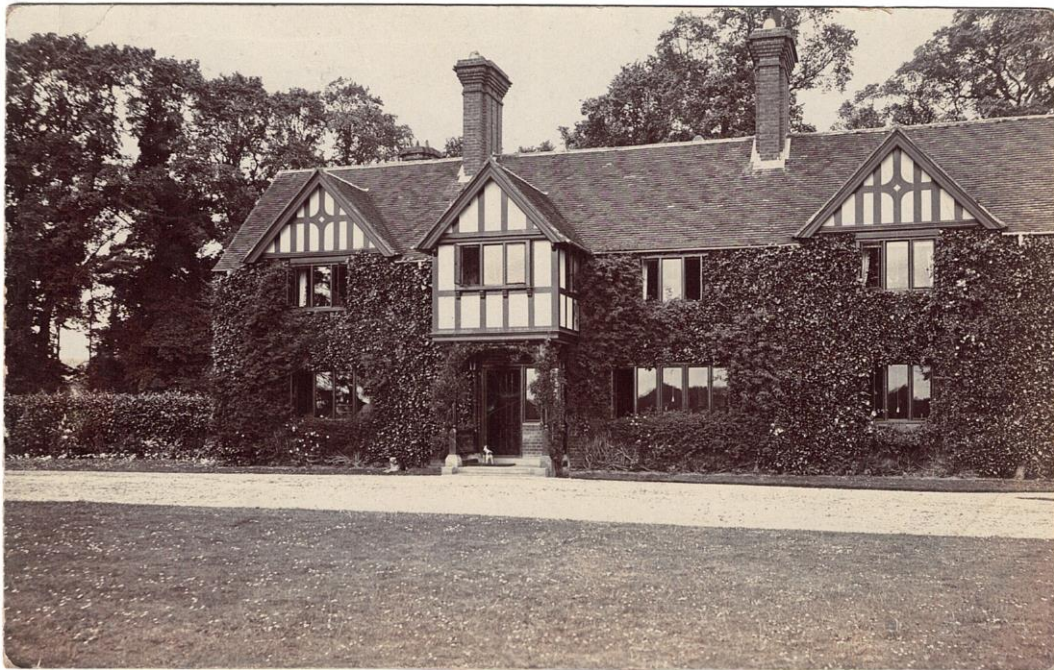
Figure 14. Postcard: photograph of Wyfold Grange postmarked July 27th 1933

The old house was demolished and the current house, from 1877 known as Wyfold Grange, was built in only a year. A number of early 20th century postcards depicting Wyfold Grange exist of which two are shown in Figures 9 and 14 and another (postmarked February 15th 1908) is on the title page.

There are echoes of the former house design seen in the 1762 drawing in the roofline, the gables and the chimney. Perhaps the 1871 house was in some measure a Victorian copy of the former house on the same footprint. The design has elements of Arts and Crafts style and is decorated with Flemish diagonal bond diapering.

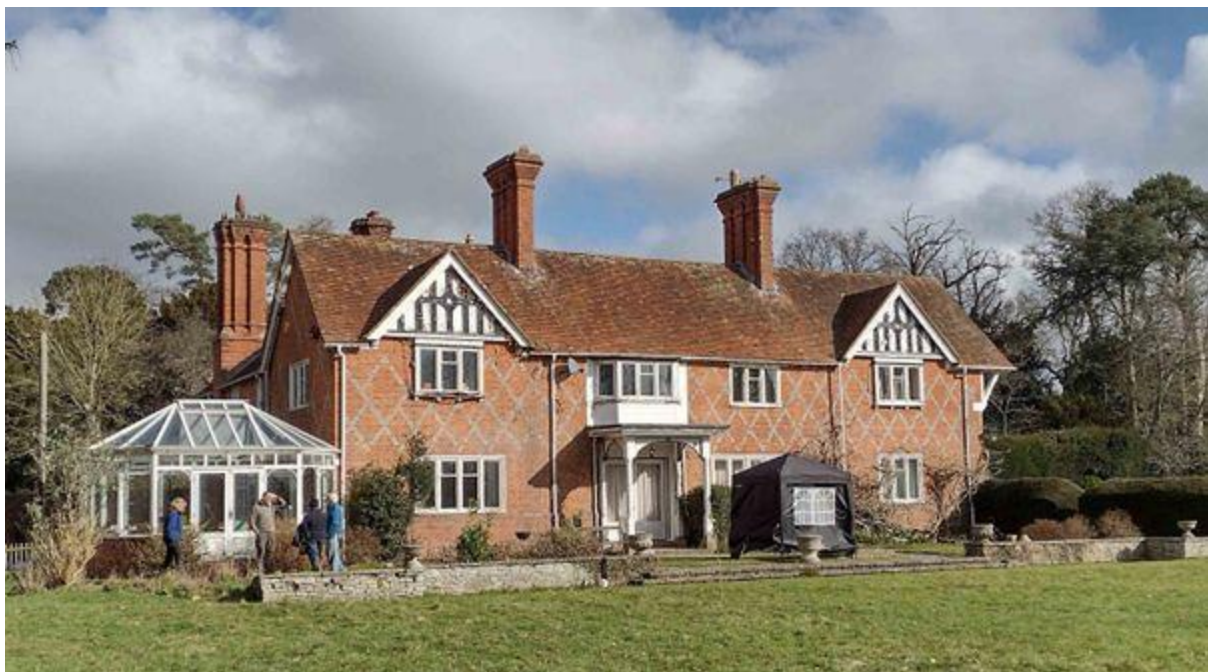
Figure 15. View of the house in 2022 taken from similar position as Figure 9

A photograph of the house taken in 2022 (Figure 15) shows that at some point in the last 100 years, believed to be in the first half of the 20th century, the house has lost its central gable but otherwise remains unchanged from the southern perspective. There have been 20th century additions to the north and east.

Members of Oxfordshire Buildings Record undertook a brief inspection of the loft space as part of this project. It was found that all roof timbers and brickwork, including chimneys, were modern, presumably dating from construction in 1871. There was no evidence of any part of the former house having been retained.

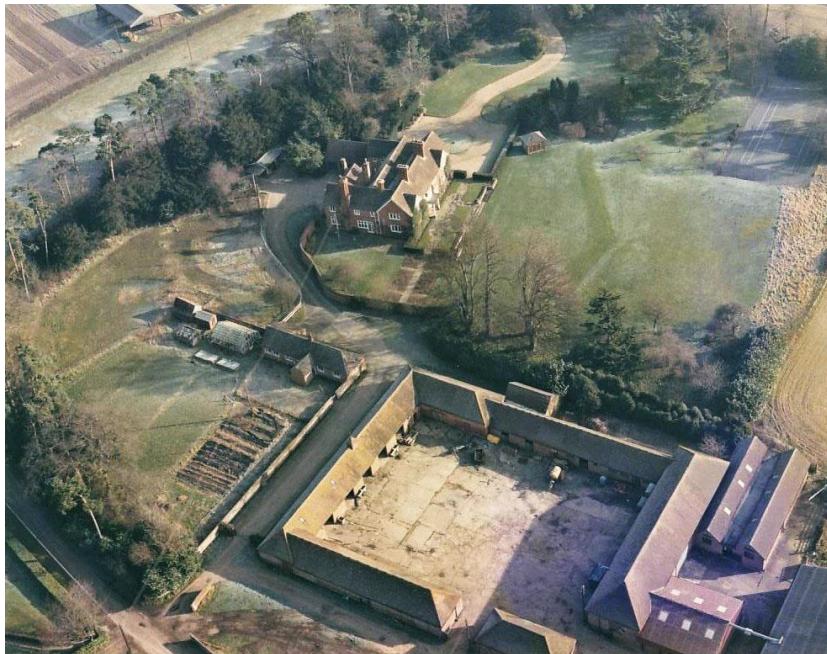
Figure 16. The stables (foreground) and cottage (centre left) c1970

The present stables buildings are of brick and knapped flint construction (Figure 16) as is the wall of the drive, to its north. It seems likely that the stables and the cottage may have been constructed contemporaneously with the house, on the footprints of former structures.

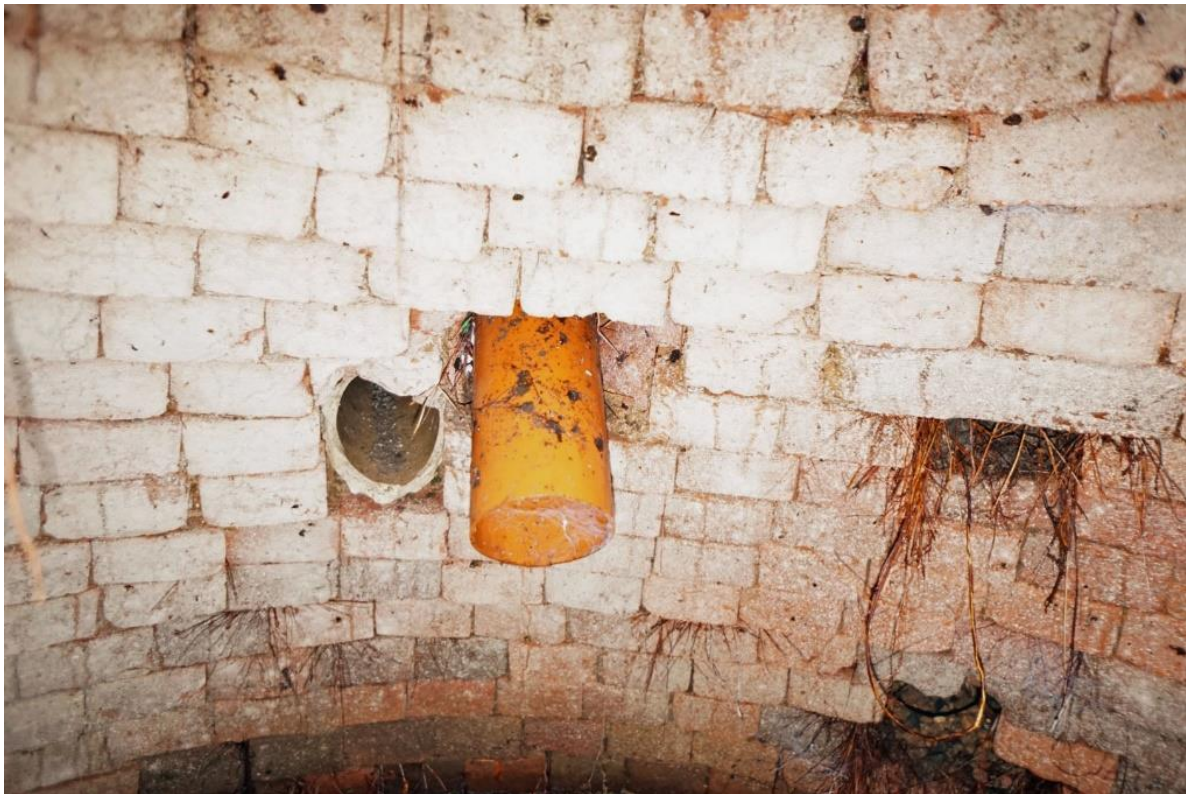
The 1898 (Figure 1) map indicates a water pump ("P") at the southeast corner of the stables. Removal of a large stone cover in this location revealed a beehive construction water cistern shown from the inside in Figure 17. Its base diameter was approximately 1.8m and potential water height approximately 1.2m giving a capacity of about 3m³ (800 gallons). The inlet pipe can be traced to show that the supply for this cistern was rainwater collected on the roof of the adjacent stables.

Figure 17 Internal photograph of the garden water cistern showing old (ceramic) and new (plastic) inlet pipes.

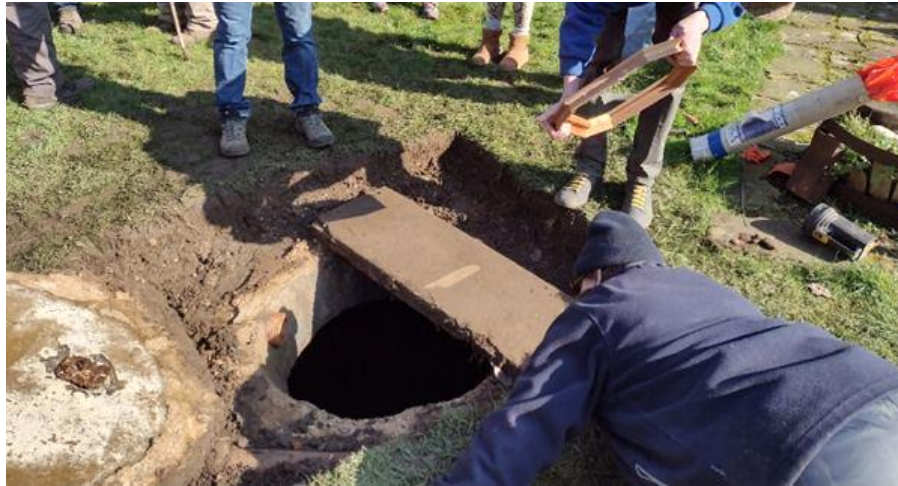
The turf was removed revealing disturbed soils and a steel ring. Further excavation using trowels and hand mattocks, exposed two large capstones, sitting more or less horizontally and side by side about 6 m from the wall of the house and 10-20 cm below the surface of the lawn. One was a rectangular stone slab just over a metre long and the other was a concrete quarter-circle cover with a large embedded ring. These covers were lifted away using the ring, to reveal an opening into a substantial cistern located directly beneath (Figure 18).

Figure 18. The house water cistern with one of the capstones removed

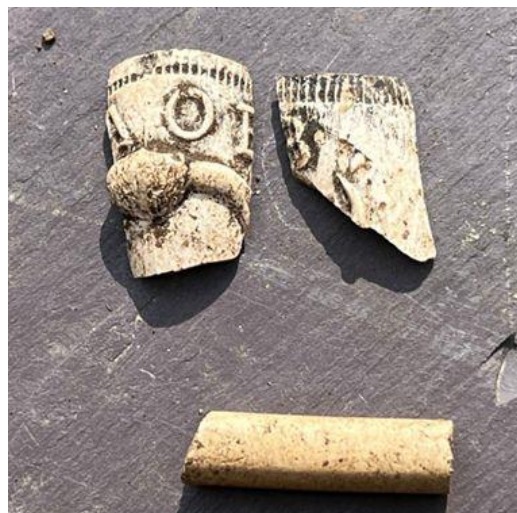
One find of particular interest was three sherds of a clay pipe shown in Figure 20. This is decorated with the letters AOB and bulls' horns. This is the emblem of the Royal Antediluvian Order of Buffaloes and the pipe is thought to be a 19th century initiation token.

Figure 20. "AOB" clay pipe
